リーマンサット

リーマンサット プロジェクト
ローバーチーム

事後プレゼン

落下試験後のまとめ

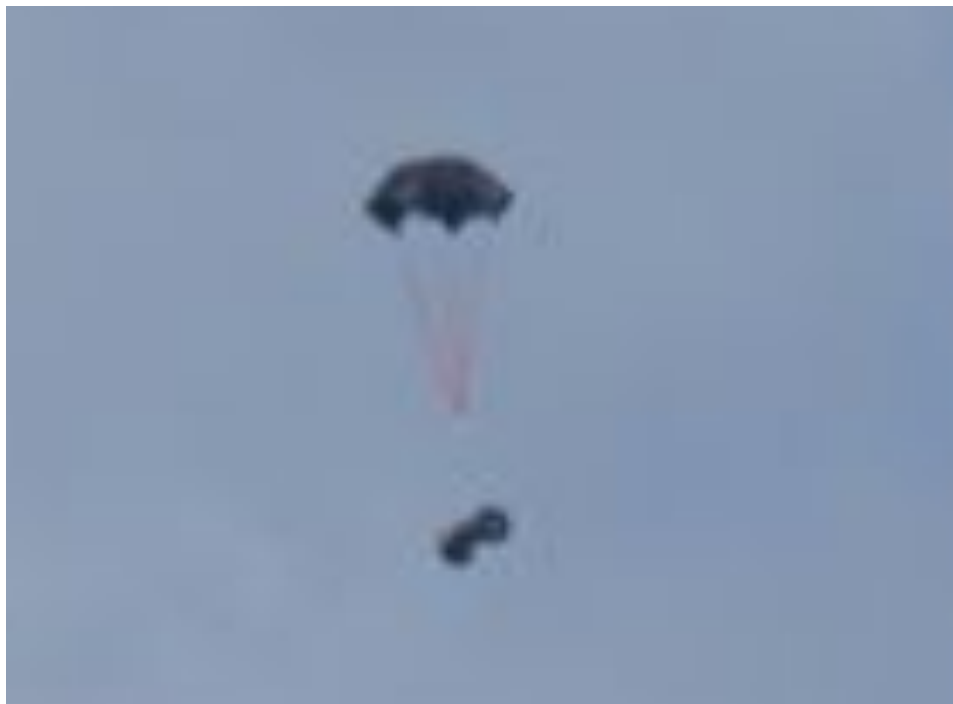
パラシュート

正常に開傘！

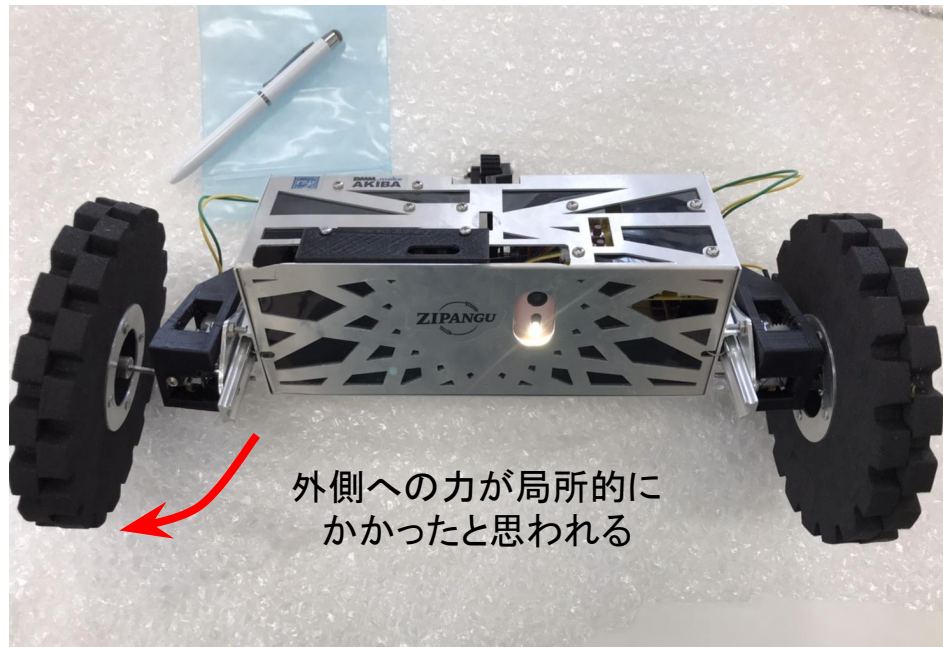
ハードウェアのエラー

落下衝撃で力が加わり、ギアボックスからシャフトが抜けた

外側への力が局所的にかかったと思われる

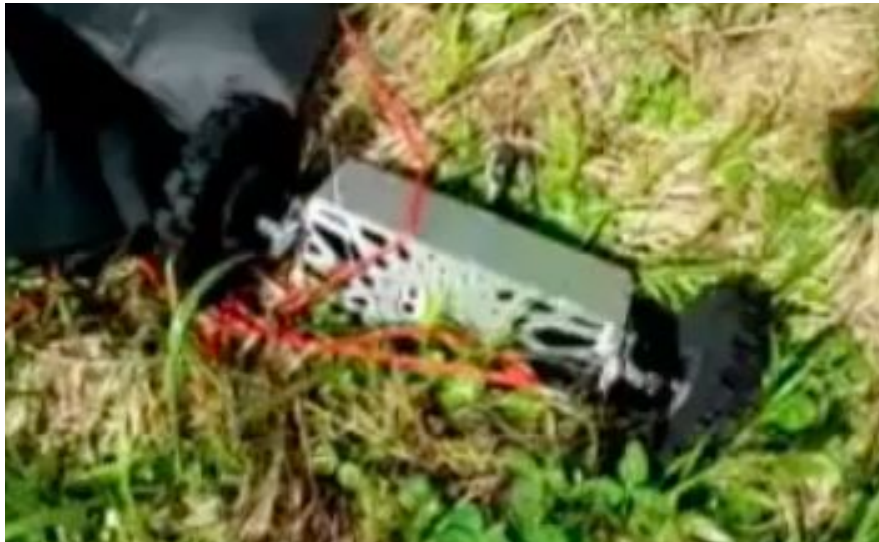
- ローバーが裏向きで着地
⇒2輪状態でしばらく走行し、姿勢が安定後に後輪を展開するシーケンスにすべきであった。

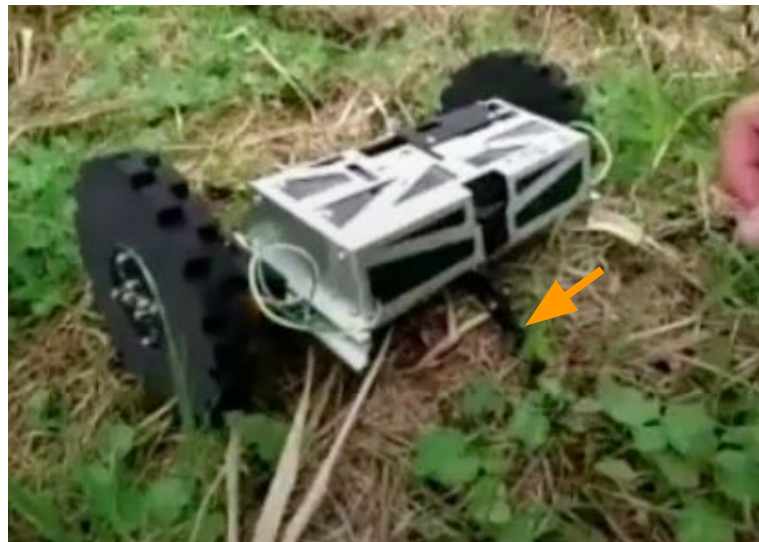
- 前輪/後輪展開機構は正常に動作
⇒後輪が地面に埋もれてしまい、ローバーが直進できず

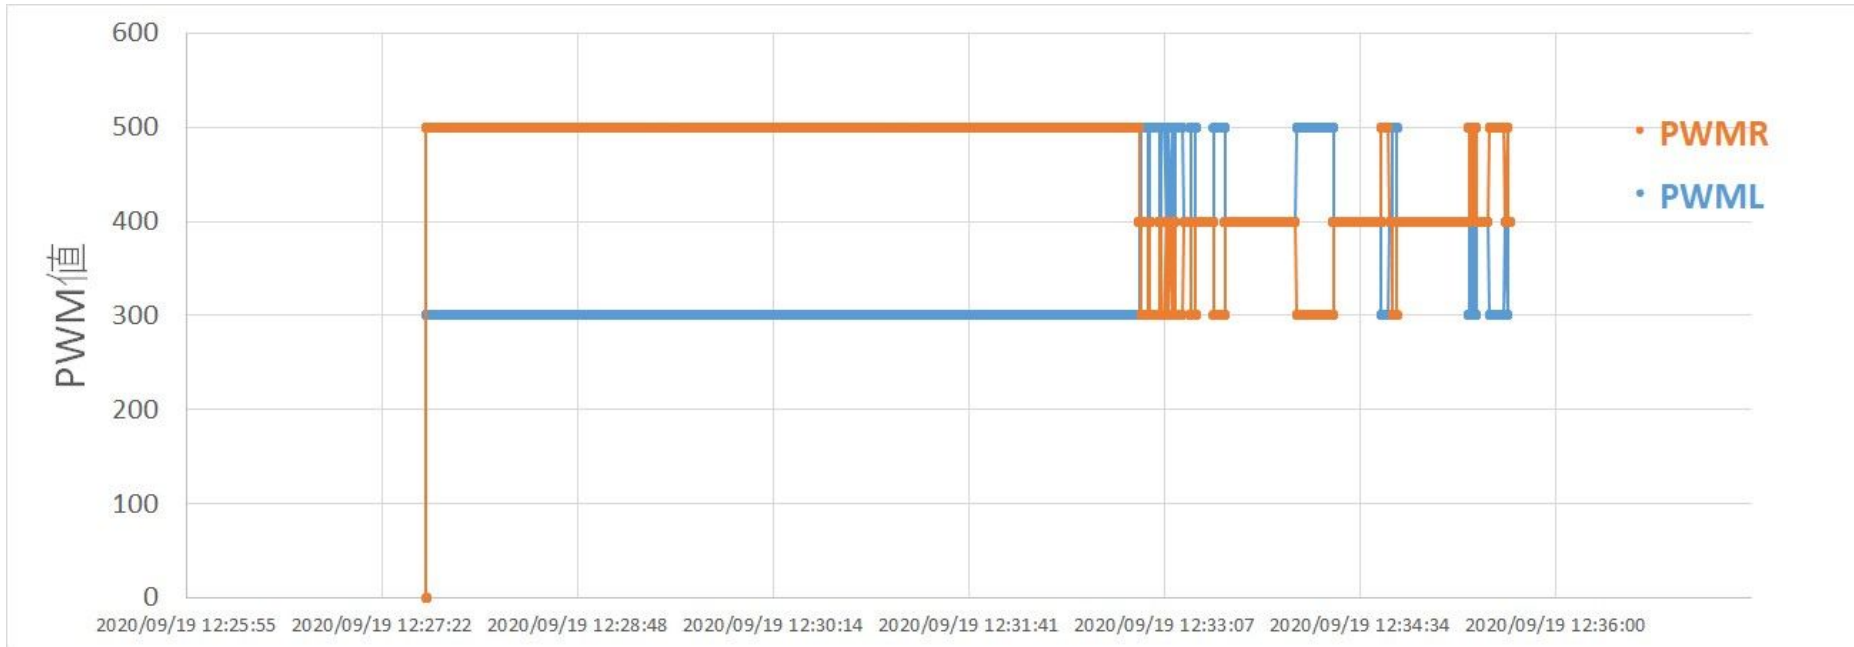
モータ出力の推移

⇒ 落下地点とARマーカが遠すぎたため、認識できず

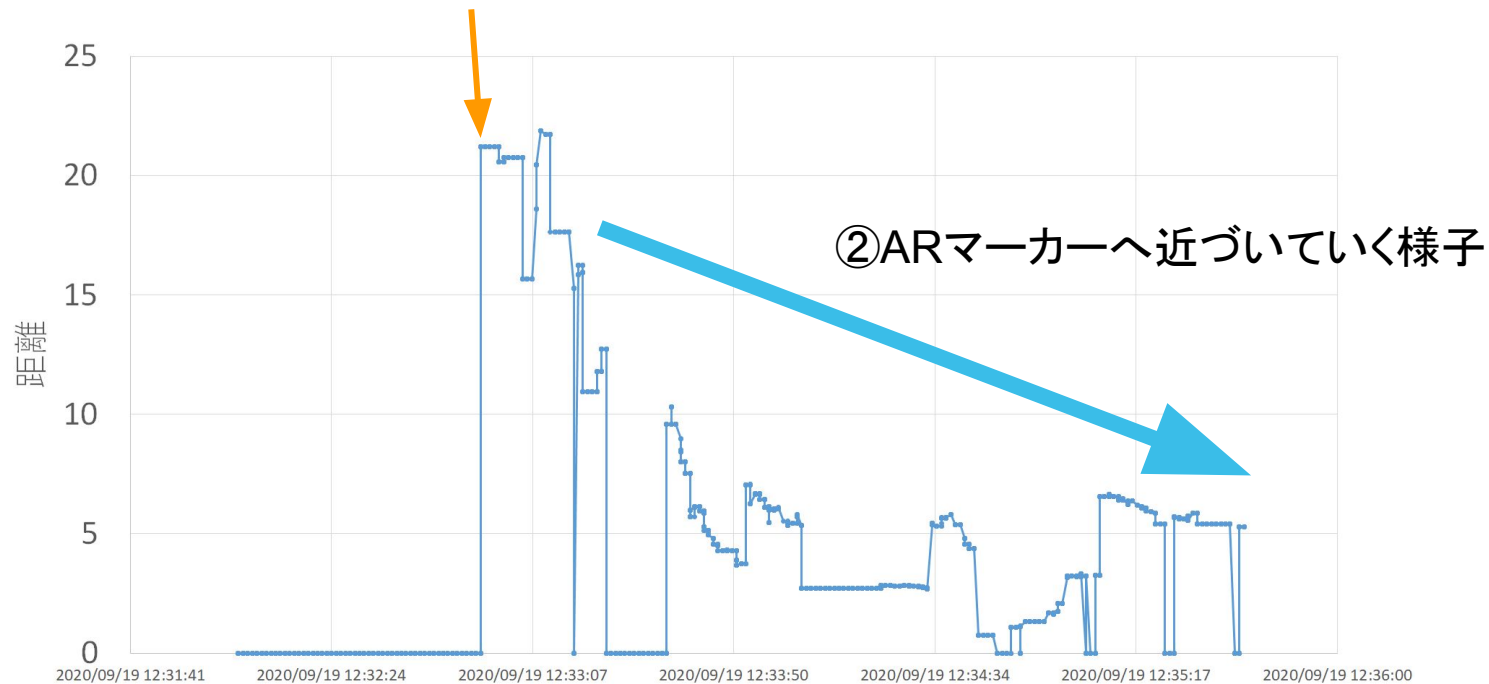
ARマーカーカーへ近づいていく際の距離グラフ

①ARマーカーカーを初めて認識

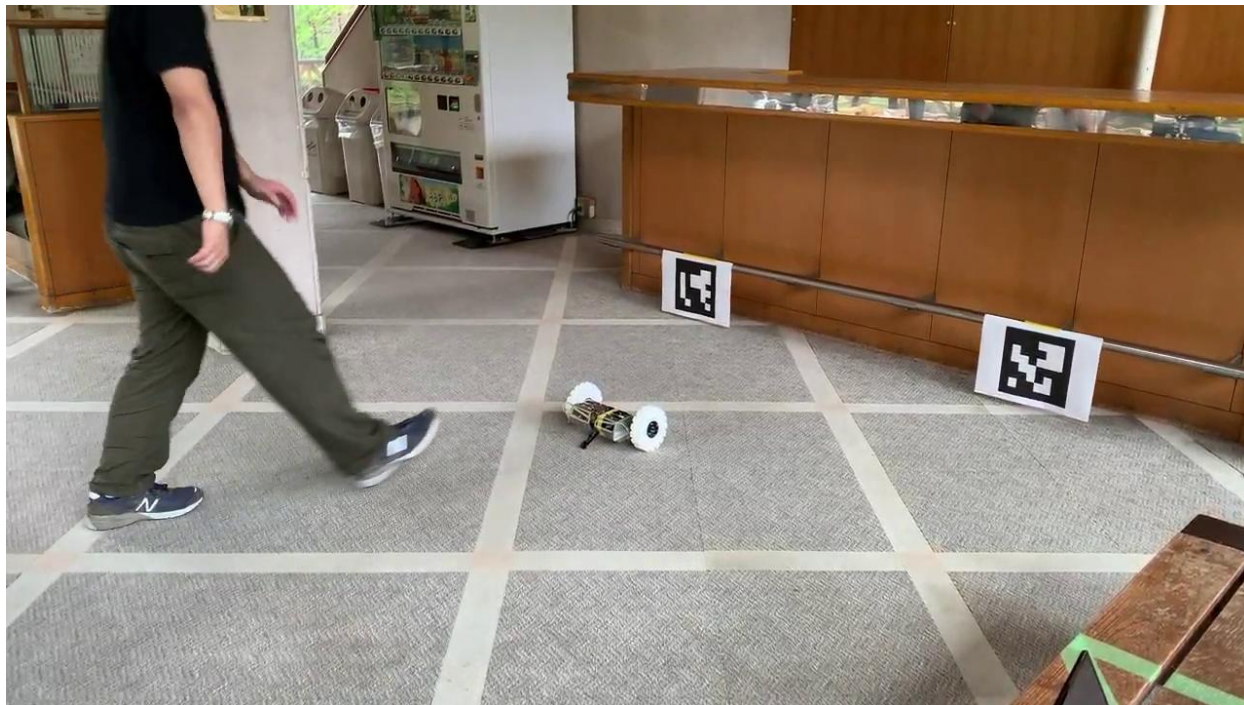
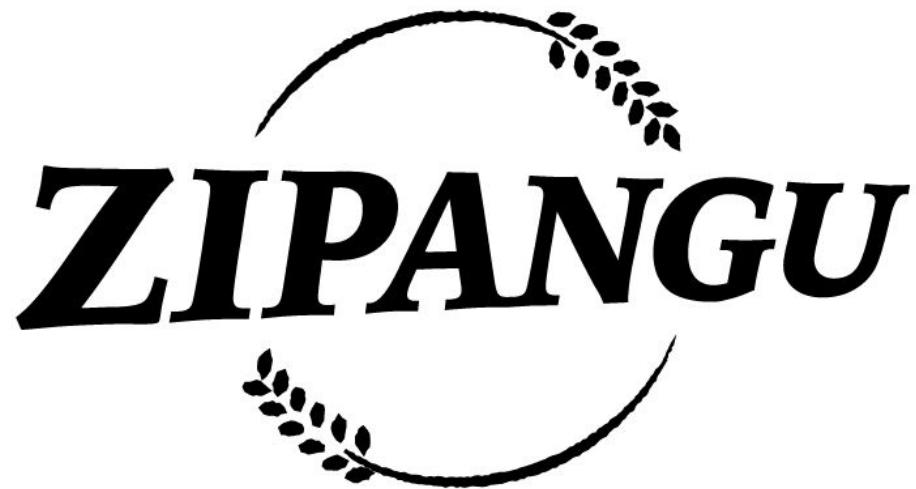
実験での動作の様子

ARマーカを認識し走行している！
